## **CHPP-Composite Helical Pipe Pile** *Beach Front Structure Shoring*

Hurricane Ivan damaged the foundation of a 3-story beachfront structure in Pensacola, Florida. Temporary shoring was used which required replacement with permanent foundations. The primary constrain was limited clearance. The location is on loose sand and it was not desirable to excavate.

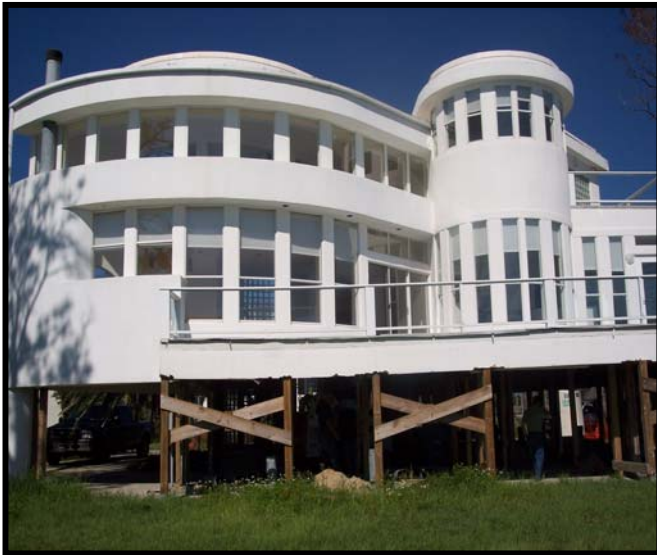
Three story home supported on temporary shoring after Hurricane damage.

The torque motor was attached to a long boom that permitted easy access. A total of 12 helical piles were installed to a depth of 20 feet with an ultimate installing torque of 20,000 ft-lbs. The helical piles were filled with concrete providing additional strength.

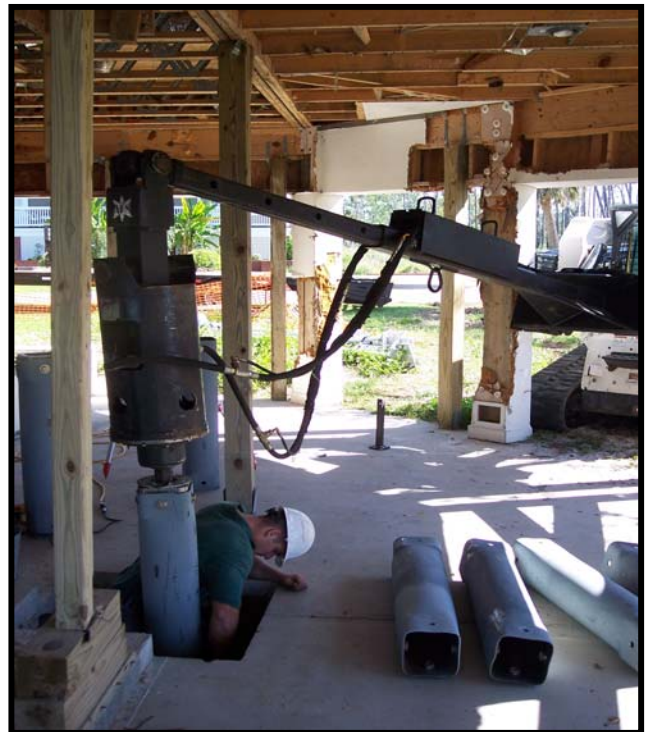
The Composite Helical Pipe Pile was easily installed in the height restricted locations and provided the most cost effective solution.
